Manhole Inspection Summary

Manhole # S31M1_011MH

Location Address: **606 Bridgeview Road**

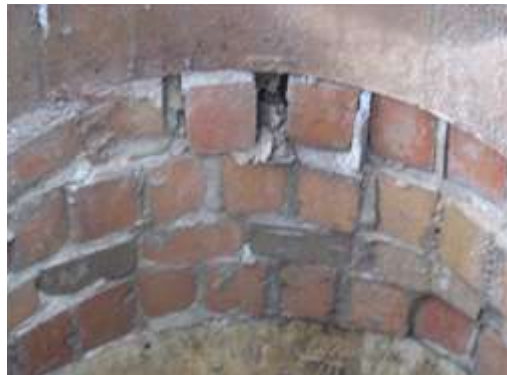
Defect 1

Condition: ☐ Sound ☐ Cracked ☐ Root Intrusion ☒ **Loose Brick** ☐ Deteriorated

Infiltration: ☐ None ☒ **Joint** ☐ Cracks ☐ Mortar ☐ Roots ☐ Wall

Infiltration

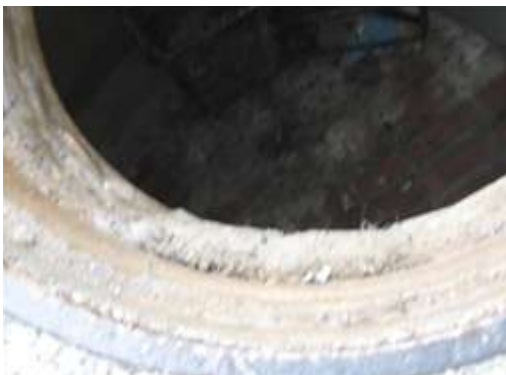
Defect 2

Offset: **1** (in.)

Frame offset

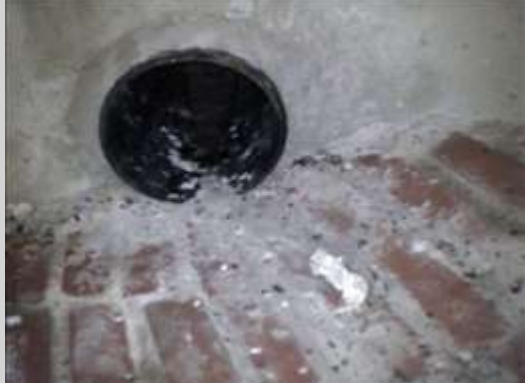
12 O'Clock Outflow

8 in. Circular Gravity Sewer
Pipe Out @ 12 O'Clock

Infiltration: **None** Pipe Seal Cond: **Sound**
